Service Bulletin

Bulletin No.: PI1059

Subject: Rotational Clicking Noise from Rear of Vehicle

Models: 2014 Chevrolet Corvette
Condition/Concern

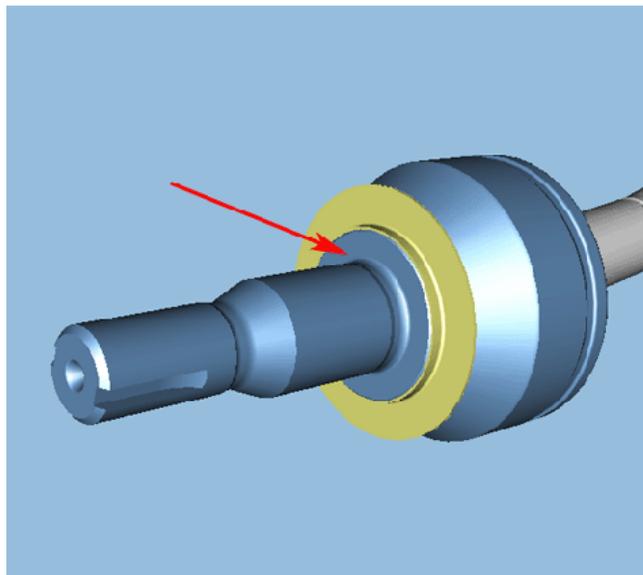
3617547

Some customers may comment on a rotational clicking noise, especially at lower speeds. The click may be heard at every wheel revolution.

This may be caused by a lack of lubrication at the rear wheel drive shaft interface with the outer bearing.

Technicians should clean the rear wheel drive shaft surface and apply a thin layer of anti-seize lubricant to the area shown below. The complete drive shaft does not need to be removed from the vehicle – only remove the knuckle side of the drive shaft to gain access to the drive shaft surface. The drive shaft nut must be replaced when performing this repair. Refer to Rear Wheel Drive Shaft Replacement in SI.
